**BEFORE THE PUBLIC UTILITIES COMMISSION OF NEVADA**

Application of Great Basin Water Co.,  
Pahrump, Spring Creek, Cold Springs,  
Pahrump, and Spanish Springs Divisions for  
Approval of its 2024 Integrated Resource  
Plan and to designate certain system  
improvement projects as eligible projects for  
which a system improvement rate may be  
established, and for relief properly related  
thereto.

## APPENDIX F

### Tank Inspection Reports and Sanitary Surveys

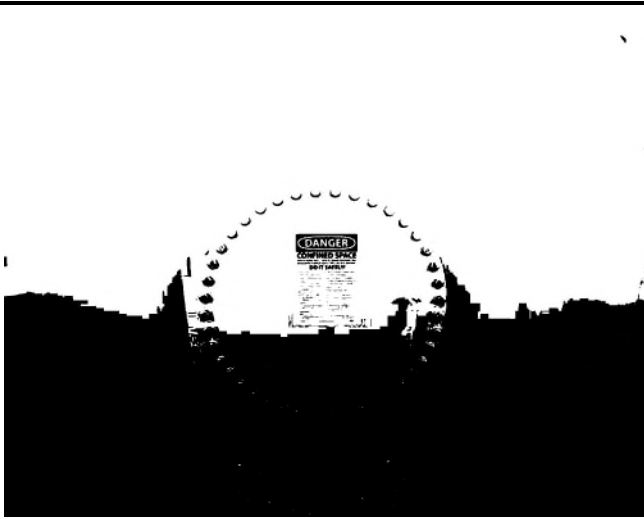
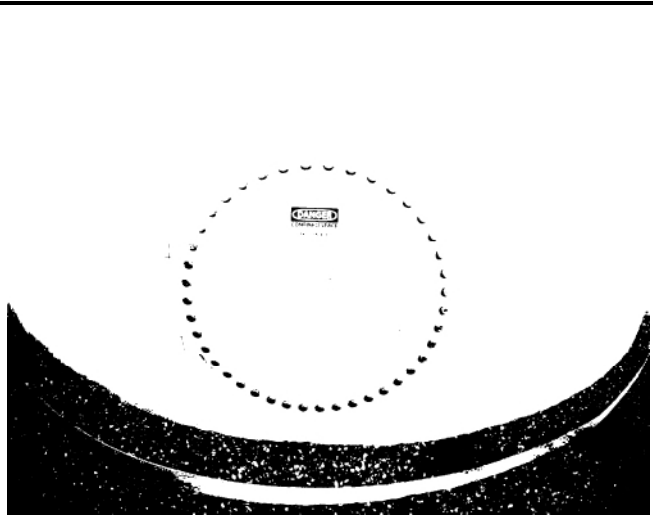
Summary: The manways were found secure and in good condition with minor de-lamination, sags & runs in the coating, chalking and 0.01% concentrated cell corrosion noted.

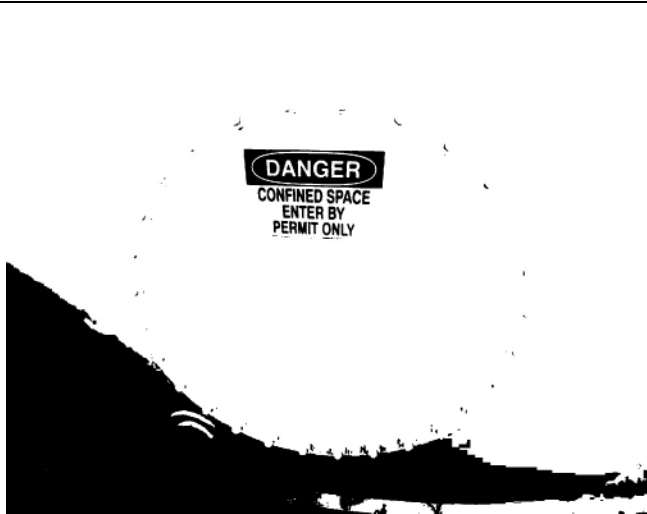
Summary: The manways were found secure and in excellent condition.

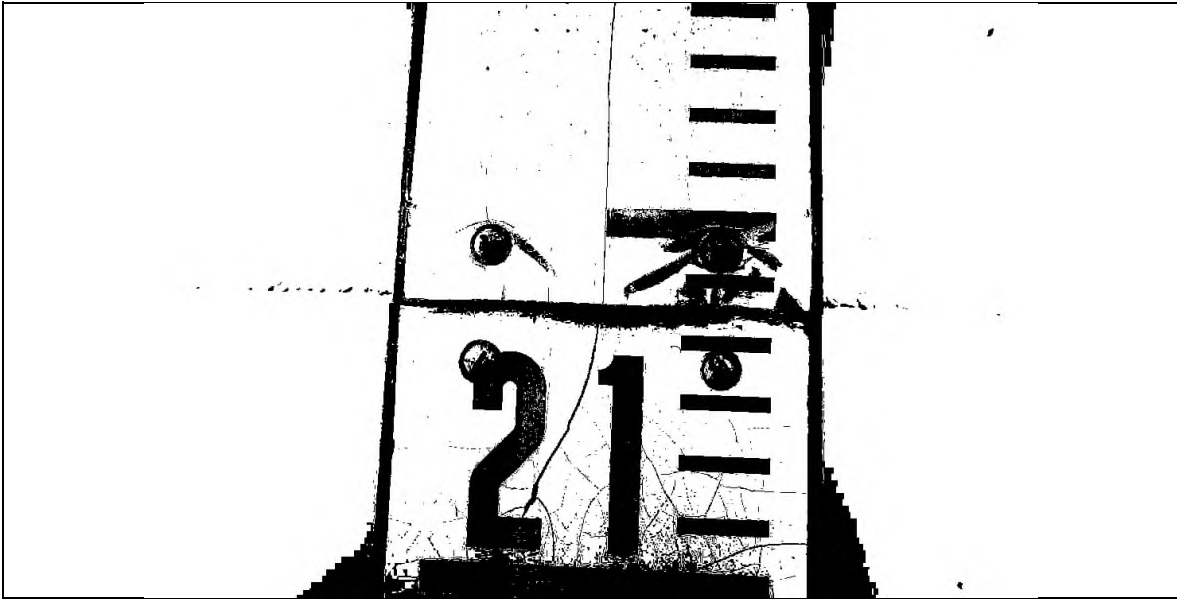
**Liquid Level Indicator**

Locking gate has rust developing.

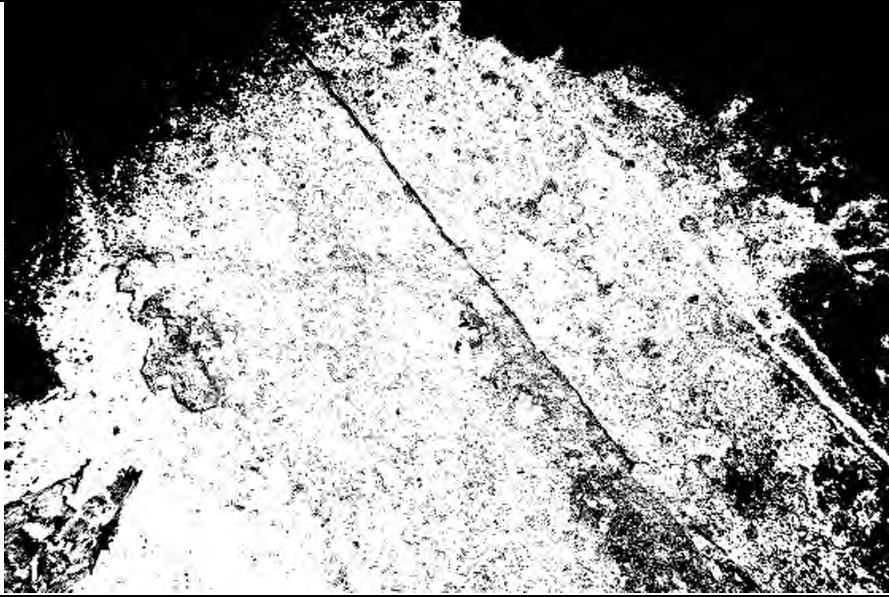
**Interior Floor**

Weld broken at seam and Leaking- Not a Lap weld - 48" long crack on weld seam.

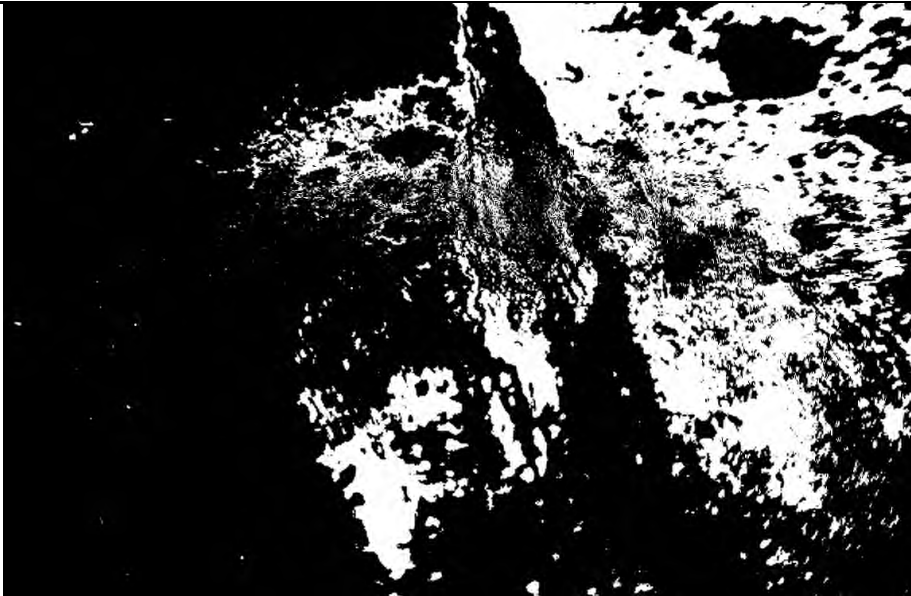
**Leak**

Crack/Leak - Butt Joint

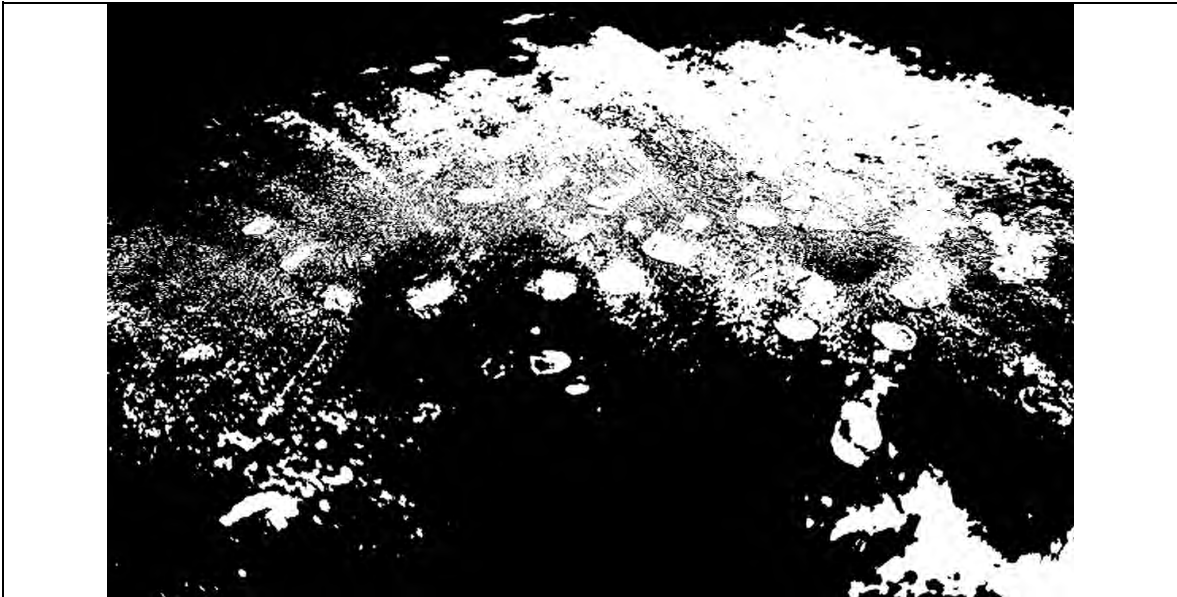
**Interior  
Floor**

Overview – General pitting

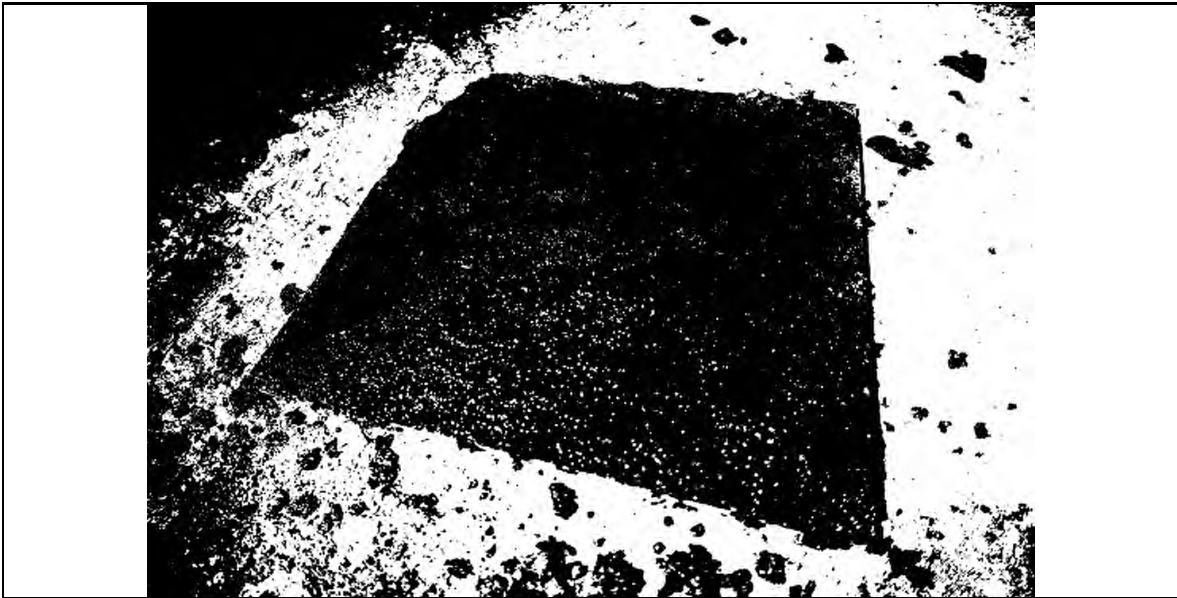
**Coupon 1**

Underside corrosion and metal loss - top left corner

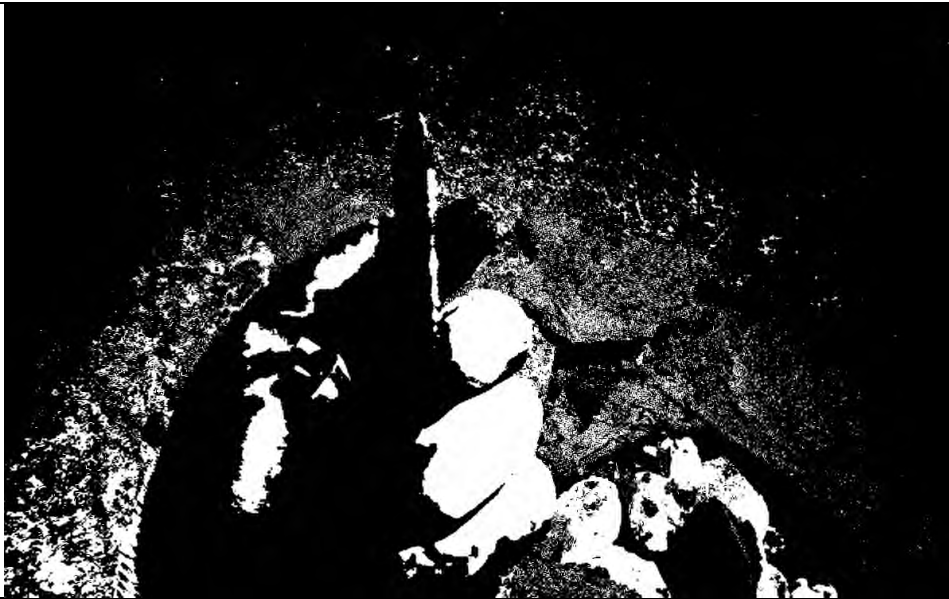
**Coupon 2**

Flaking Rust / Heavy Underside Corrosion

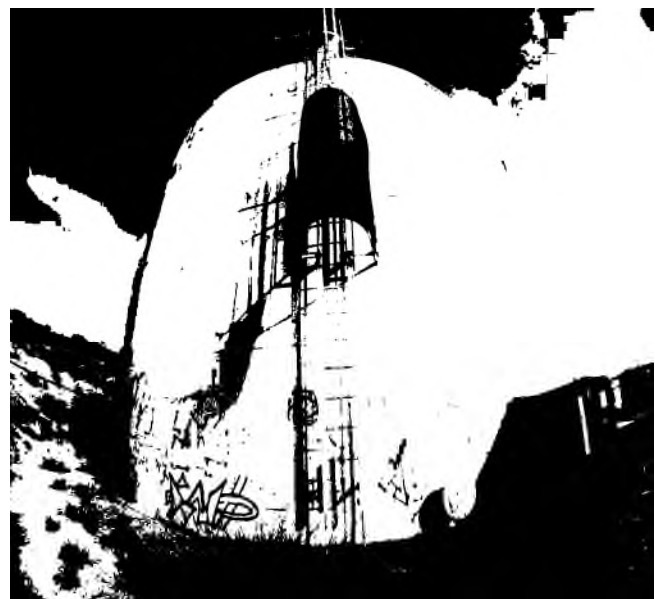
Summary: The ladder was found secure, OSHA approved and in good condition with minor corrosive staining, sags & runs in the coating, minor to moderate de-lamination and 0.01% uniform surface corrosion & concentrated cell corrosion noted.

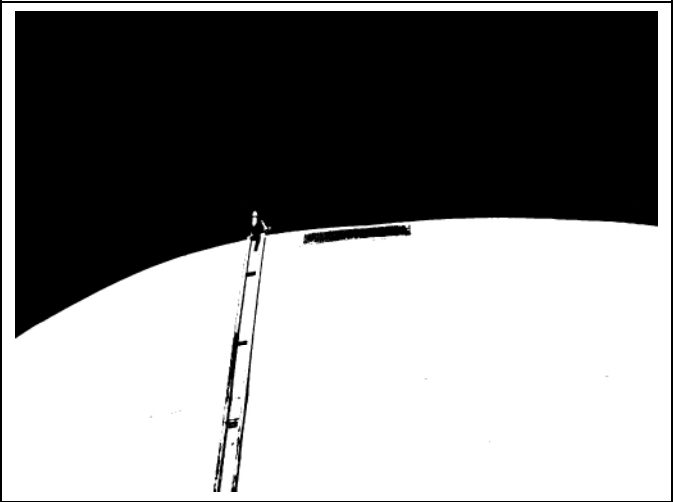
Summary: The six vents were found in good to fair condition with heavy de-lamination, corrosive staining and greater than 50% concentrated cell corrosion & uniform surface corrosion noted.

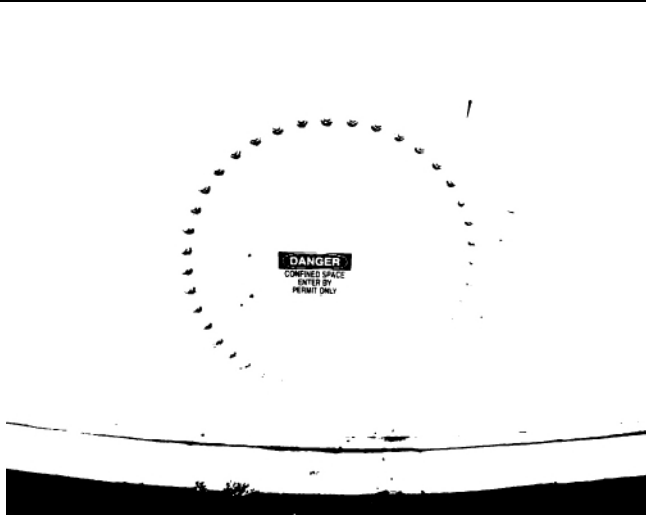
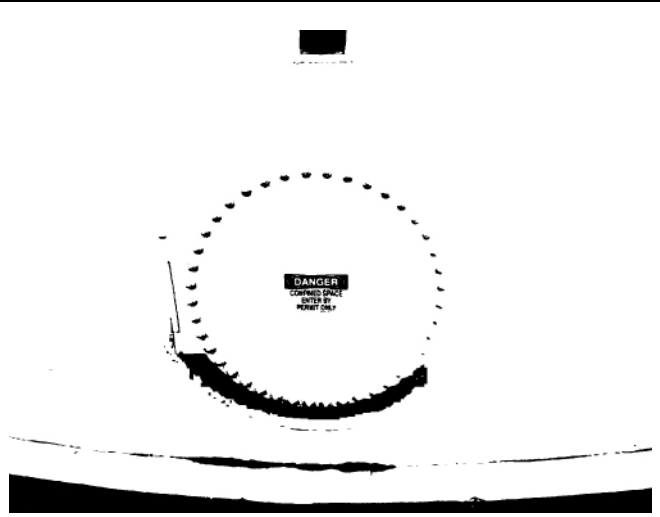
Summary: The manways were found secure and in good condition.
