**BEFORE THE PUBLIC UTILITIES COMMISSION OF NEVADA**

Application of Great Basin Water Co.,  
Pahrump, Spring Creek, Cold Springs,  
Pahrump, and Spanish Springs Divisions for  
Approval of its 2024 Integrated Resource  
Plan and to designate certain system  
improvement projects as eligible projects for  
which a system improvement rate may be  
established, and for relief properly related  
thereto.

## APPENDIX F

### Tank Inspection Reports and Sanitary Surveys

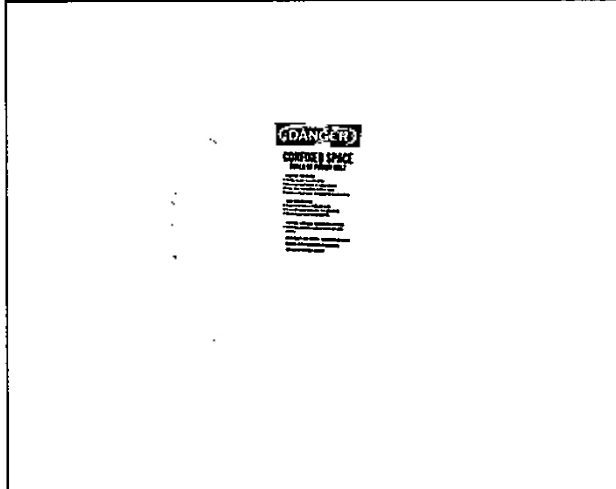
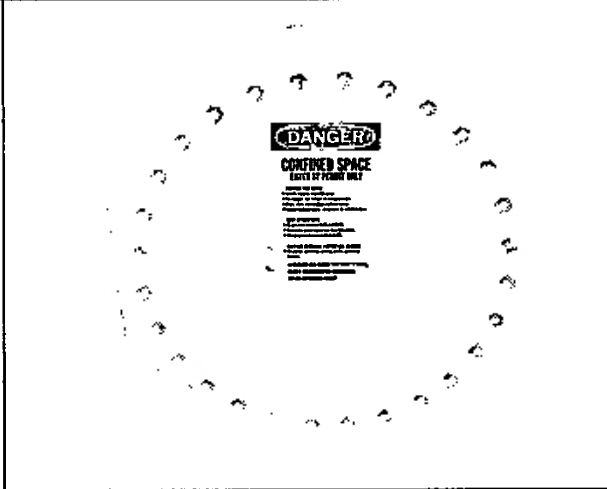
**Manway Condition**

De-lamination Present? Y  N   
 Summary: The manways were found secure and in good condition with heavy chalking noted.

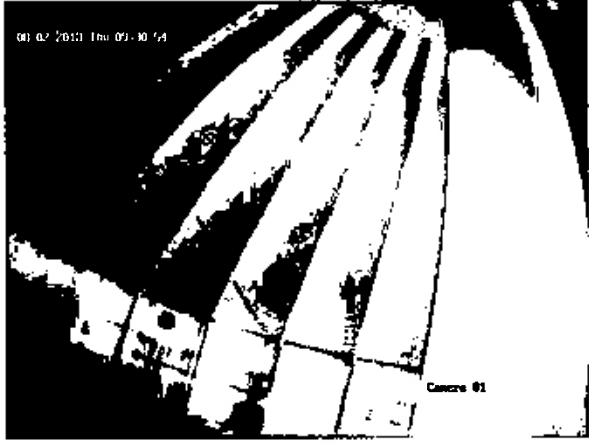
<b>Roof Condition</b>	
<p>Coating Condition: Good            Welds/seam Condition: Good            Corrosion Present On Panels? Y <input checked="" type="checkbox"/> N <input type="checkbox"/>            Metal De-alloying Present? Y <input type="checkbox"/> N <input checked="" type="checkbox"/>            Oxidation Present? Y <input type="checkbox"/> N <input checked="" type="checkbox"/></p>	<p>De-lamination Present? Y <input checked="" type="checkbox"/> N <input type="checkbox"/>             Summary: The interior roof was found in good condition with minor de-lamination, staining, 0.01% uniform surface corrosion and rust noduling noted.</p>

1. Schedule time for epoxy repairs to the problem areas in the tank. (Approximately 1/2 day)
2. Continue to schedule a clean and inspect every 3-5 years per AWWA recommendations.

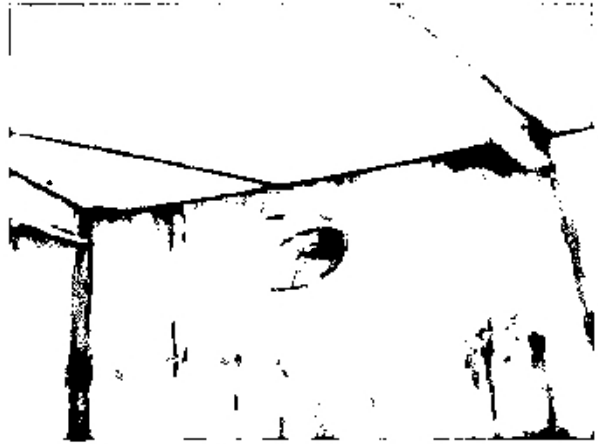
### Overflow Condition

Summary: The overflow was found in good condition with minor to moderate de-lamination and 0.03% uniform surface corrosion noted.

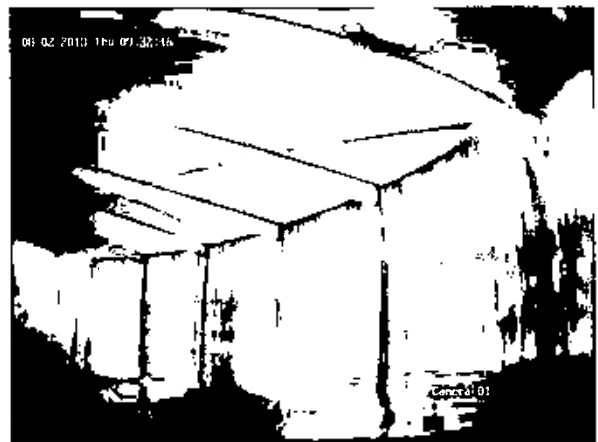
### Wall Panel Condition

Summary: The interior wall was found in good condition with minor staining, 0.01% rust noduling and 1% uniform surface corrosion noted.

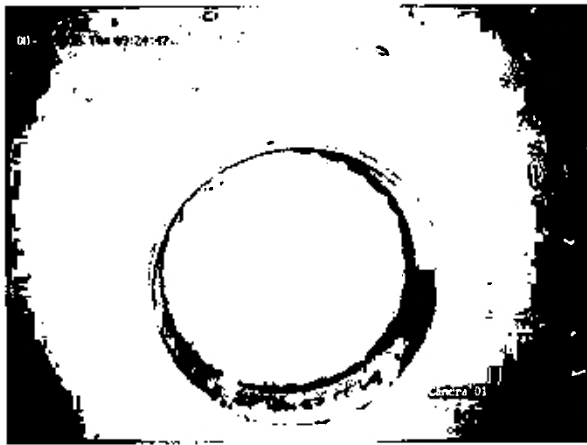
### Manway Condition

Summary: The manways were found in good condition with minor de-lamination, blistering, minor to moderate staining and 0.01% rust noduling noted.

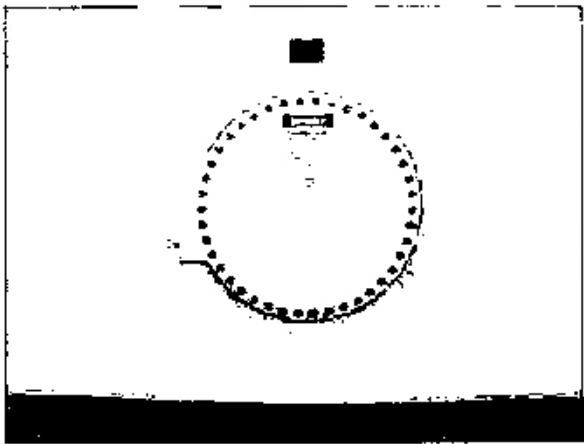
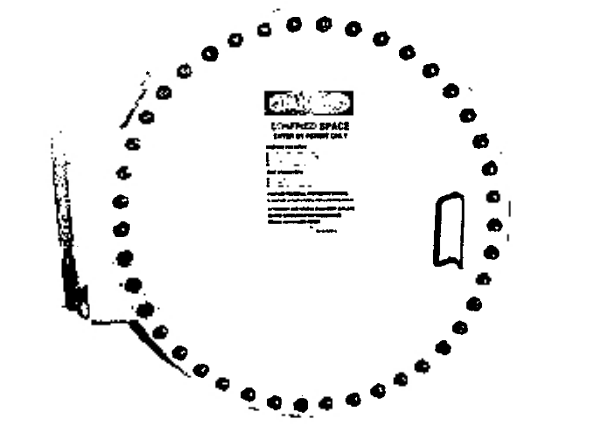
<b>Manway Condition</b>	
<p>           Coating Condition: Excellent/Good            Weld/Seam Condition: Excellent            Corrosion Present? Y <input checked="" type="checkbox"/> N <input type="checkbox"/>            Oxidation Present? Y <input type="checkbox"/> N <input checked="" type="checkbox"/>            De-lamination Present? Y <input type="checkbox"/> N <input checked="" type="checkbox"/> </p>	<p>Summary: The manways were found secure and in excellent to good condition with 0.01% uniform surface corrosion noted.</p>

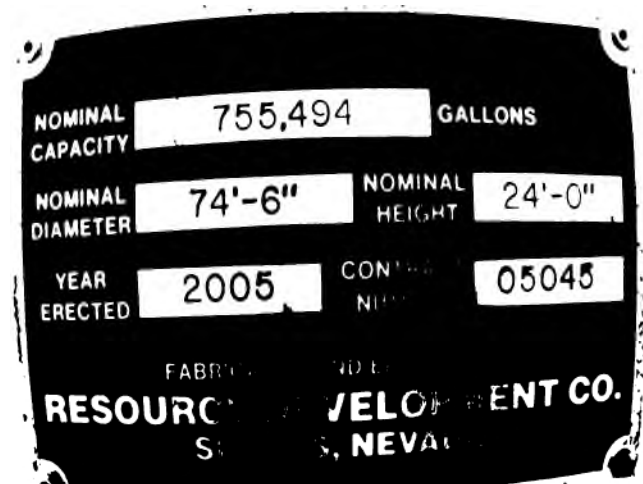
Summary: The wall was found in good condition with minor de-lamination, staining and chalking noted.

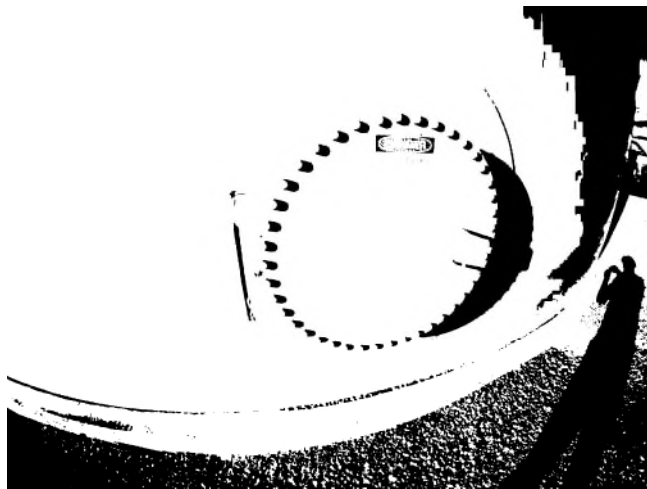
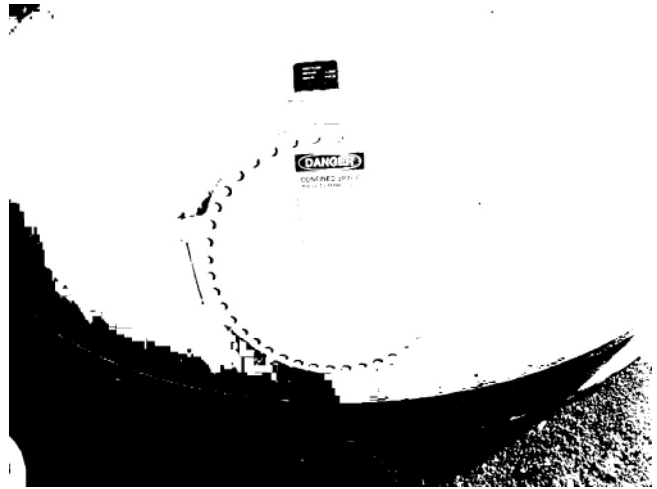
Summary: The manways were found secure and in good condition with minor chalking and staining noted.

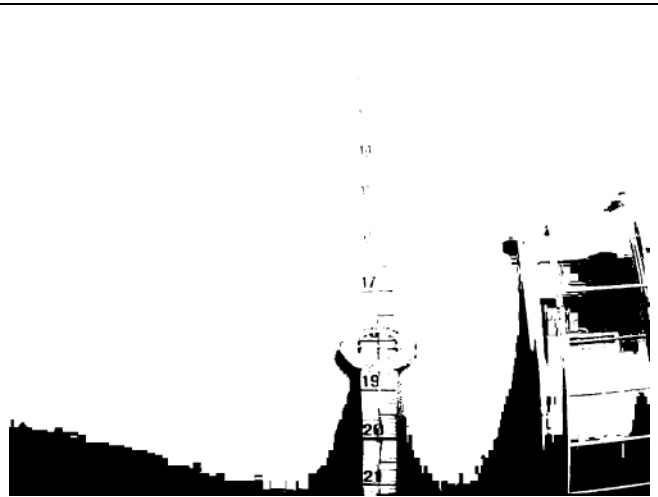
Summary: The water level indicator was found in good condition.

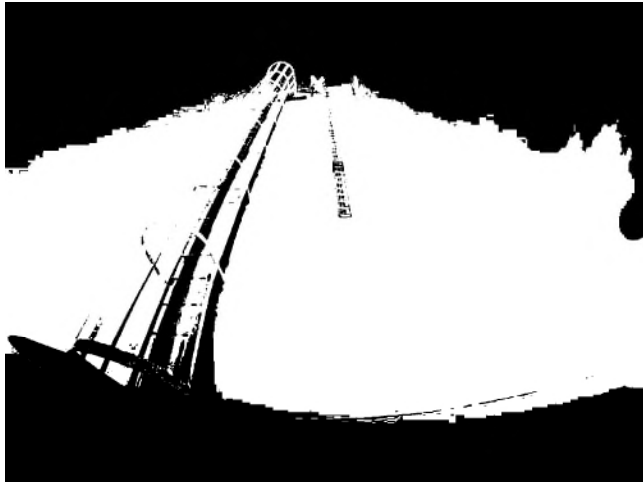
Summary: The wall was found in good condition with minor chalking noted.

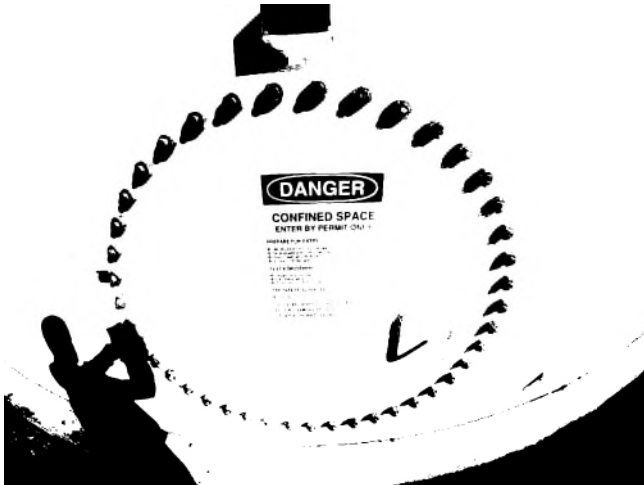
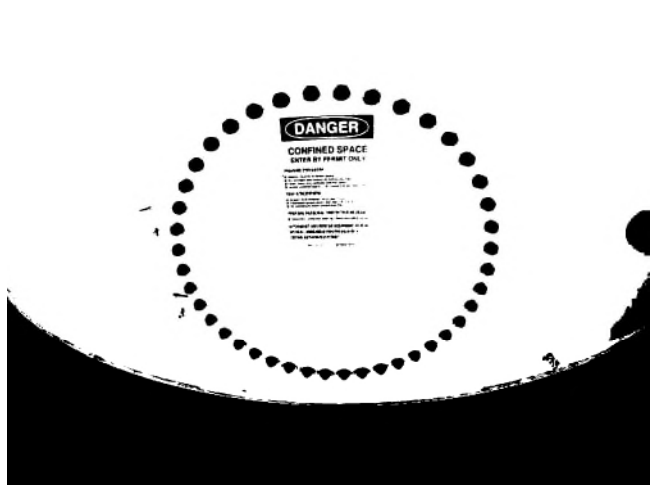
Summary: The manways were found secure and in good condition with minor chalking noted.

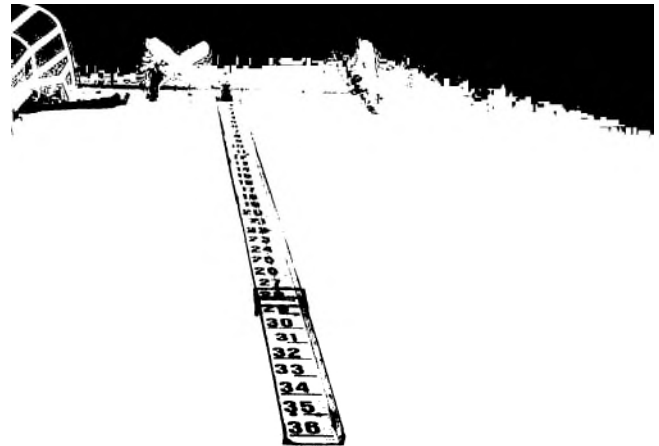
Summary: The water level indicator was found in good condition.

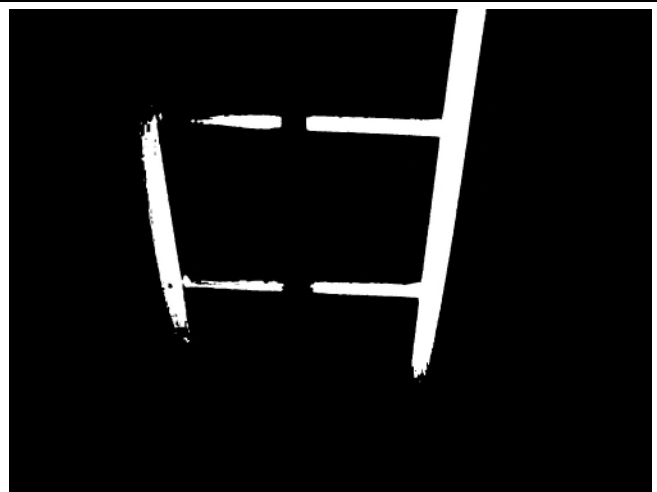
Summary: The ladder was found secure and in good condition with moderate sediment staining and 0.01% rust noduling noted.

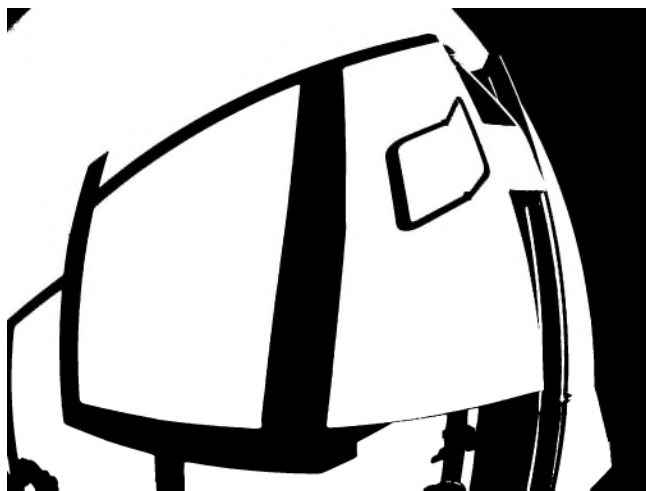
Summary: The hatch was found locked with a gasket in place and in good condition with minor sags & runs in the coating and chalking noted.

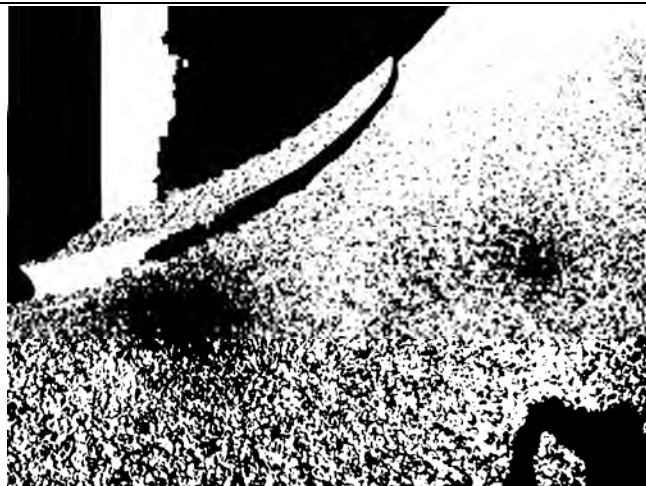
Summary: The base of the tank was found in good condition.

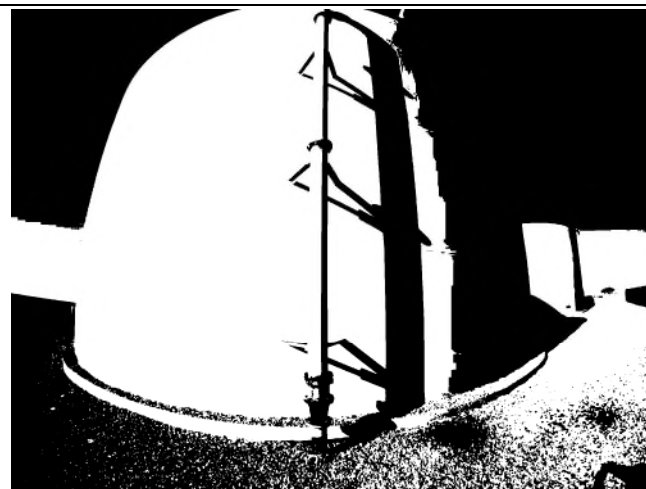
Summary: The overflow was found in good condition with minor de-lamination, sags & runs in the coating, chalking and 0.01% concentrated cell corrosion noted.

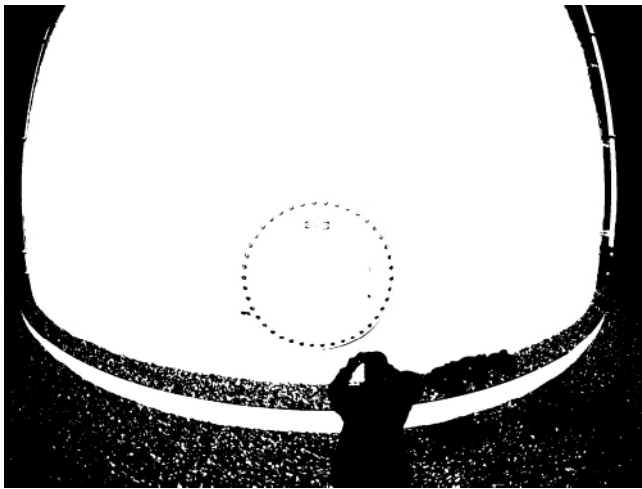
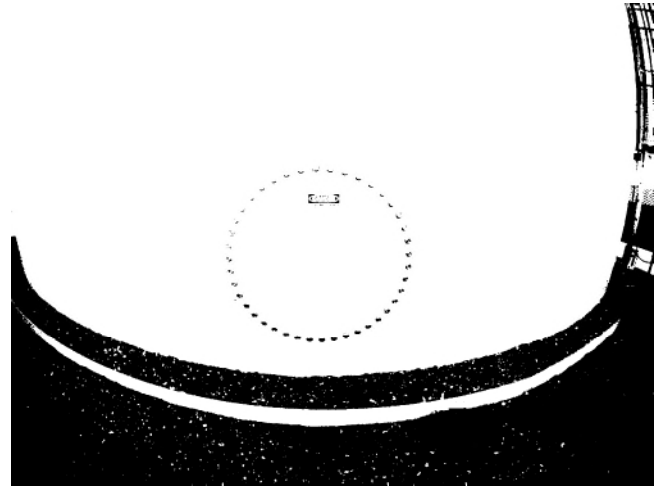
Summary: The manways were found secure and in good condition with minor de-lamination, sags & runs in the coating, chalking and 0.01% concentrated cell corrosion noted.

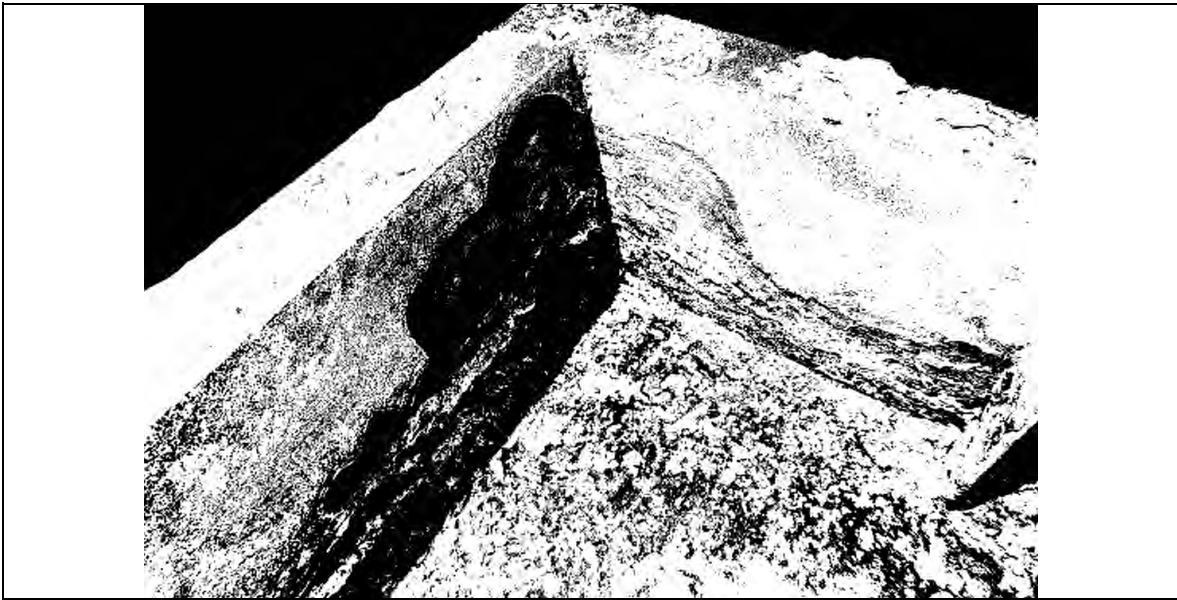
**Center  
Column**

Overview / Corrosion

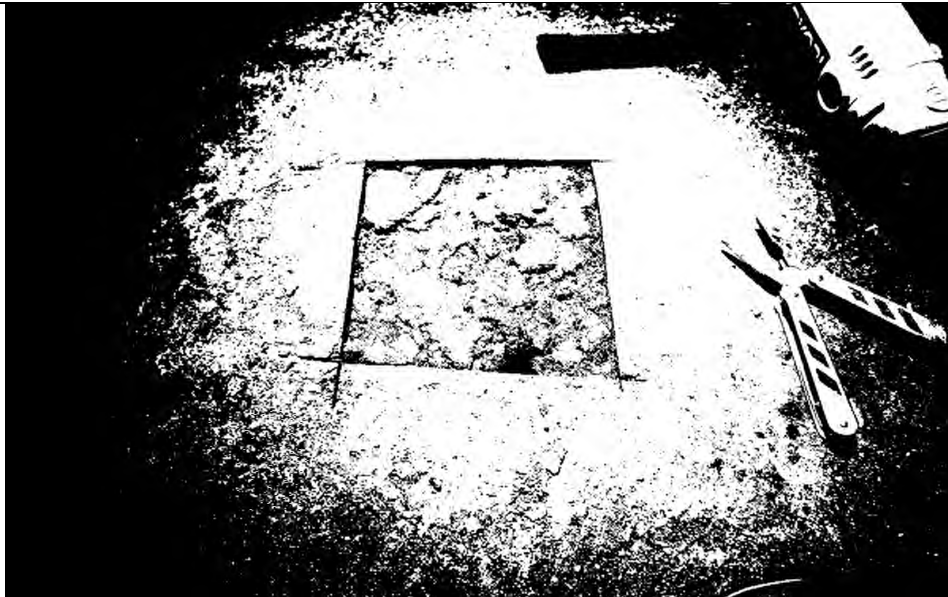
**Underside  
Tank Floor**

Corrosion

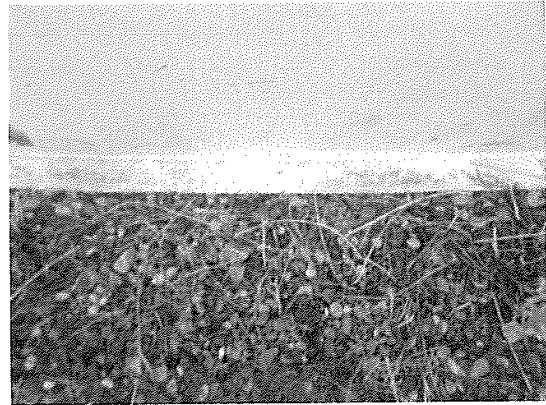
**Foundation Condition**

Summary: The base of the tank was found in good condition.

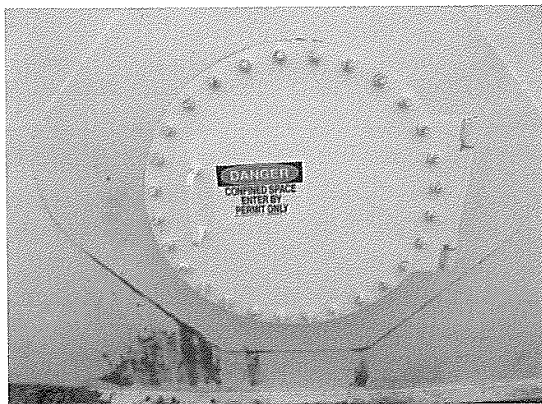
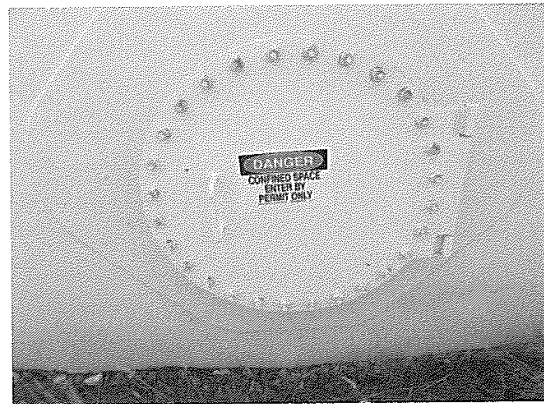
**Manway Condition**

Summary: The manways were found secure and in good condition with oxidation and less than 1% surface corrosion noted.

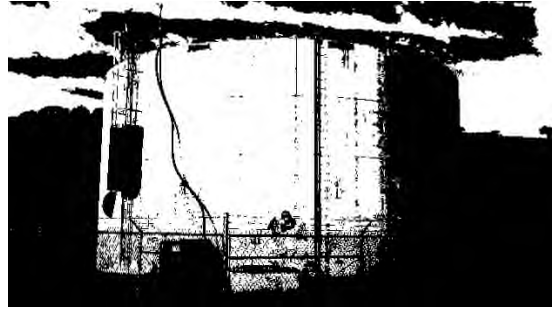
<b>Location:</b>	Exterior		
<b>Area:</b>	Shell		
<b>Adhesion:</b>	2A		
<b>Overall Condition:</b>	Poor		
<b>Dry Film Thickness:</b>	<b>Minimum</b>	<b>Maximum</b>	<b>Average</b>
	0.90	15.8	7.6

Condition	<i>Severe</i>	<i>Advanced</i>	<i>Moderate</i>	<i>Slight</i>	<i>None/NA</i>
<b>Rusting</b>			●		
<b>Blistering</b>					●
<b>Cracking</b>			●		
<b>Peeling</b>			●		
<b>Pitting</b>					●
<b>Chalking</b>	●				
<b>Delamination</b>			●		
<b>Comments:</b> Moderate rusting, cracking, peeling and delamination throughout, severe chalking throughout, various locations with observed damage from shotgun fire

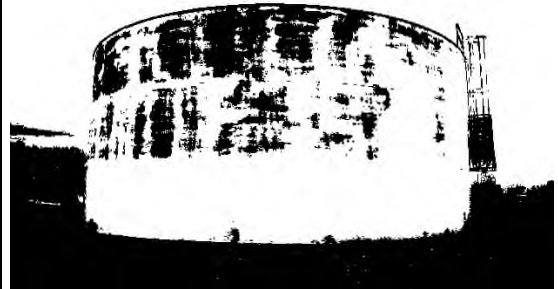
<b>Location:</b>	Exterior		
<b>Area:</b>	Upper Shell		
<b>Adhesion:</b>	-		
<b>Overall Condition:</b>	Poor		
<b>Dry Film Thickness:</b>	<b>Minimum</b>	<b>Maximum</b>	<b>Average</b>
	0.6	1.2	0.9

Condition	<i>Severe</i>	<i>Advanced</i>	<i>Moderate</i>	<i>Slight</i>	<i>None/NA</i>
<b>Rusting</b>			●		
<b>Blistering</b>					●
<b>Cracking</b>					●
<b>Peeling</b>					●
<b>Pitting</b>					●
<b>Chalking</b>	●				
<b>Delamination</b>					●
<b>Comments:</b> Moderate rusting in localized areas and roof edge, severe chalking throughout, minimal coating remains

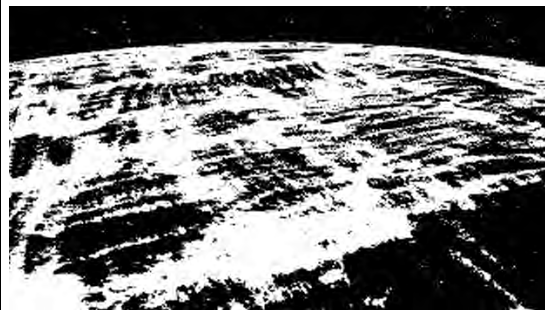
<b>Location:</b>	Exterior		
<b>Area:</b>	Roof		
<b>Adhesion:</b>	-		
<b>Overall Condition:</b>	Poor		
<b>Dry Film Thickness:</b>	<b>Minimum</b>	<b>Maximum</b>	<b>Average</b>
	0.25	2.1	1.4

Condition	<i>Severe</i>	<i>Advanced</i>	<i>Moderate</i>	<i>Slight</i>	<i>None/NA</i>
<b>Rusting</b>			●		
<b>Blistering</b>					●
<b>Cracking</b>					●
<b>Peeling</b>					●
<b>Pitting</b>					●
<b>Chalking</b>	●				
<b>Delamination</b>					●
<b>Comments:</b> Moderate rusting in localized areas, severe chalking throughout, minimal coating remains

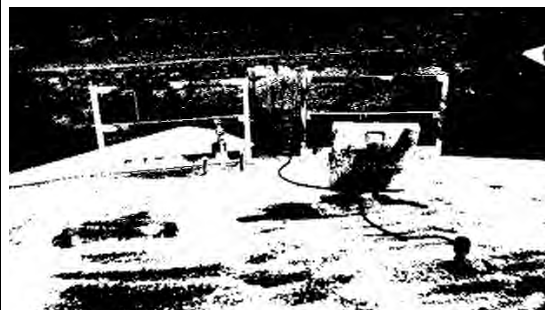
<b>Location:</b>	Exterior		
<b>Area:</b>	Handrail/Manway		
<b>Adhesion:</b>	-		
<b>Overall Condition:</b>	Poor		
<b>Dry Film Thickness:</b>	<b>Minimum</b>	<b>Maximum</b>	<b>Average</b>
	-	-	-

Condition	<i>Severe</i>	<i>Advanced</i>	<i>Moderate</i>	<i>Slight</i>	<i>None/NA</i>
<b>Rusting</b>			●		
<b>Blistering</b>					●
<b>Cracking</b>					●
<b>Peeling</b>					●
<b>Pitting</b>					●
<b>Chalking</b>	●				
<b>Delamination</b>					●
<b>Comments:</b> Moderate rusting in localized areas, severe chalking throughout, minimal coating remains

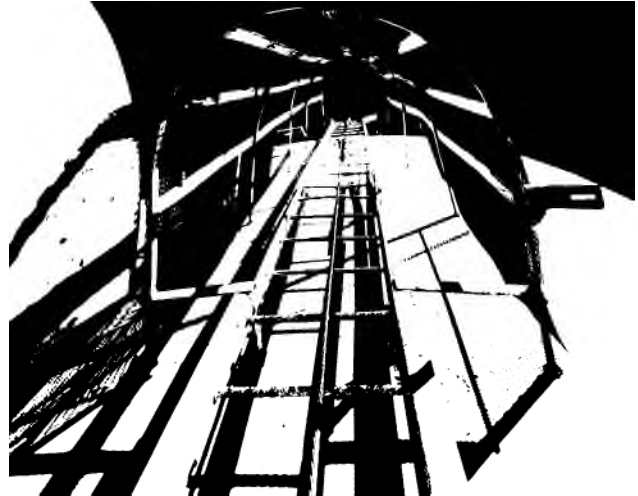
Summary: The ladder was found secure and in fair condition with de-lamination, oxidation and 2% surface corrosion noted. The cable is loose and must be tightened to make it OSHA approved.

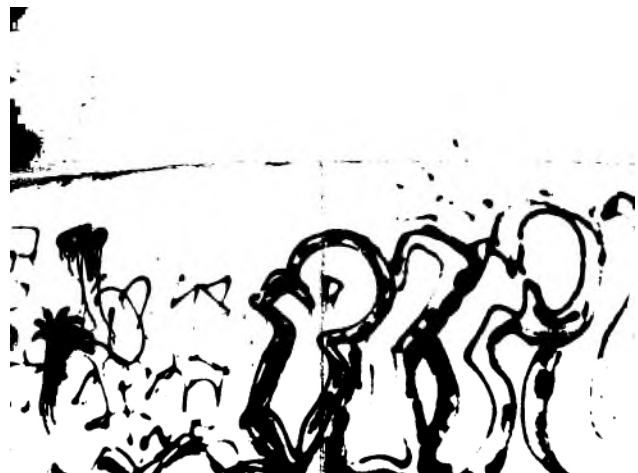
Summary: The wall was found in fair condition with sags & runs in the coating, de-lamination, oxidation, graffiti and 5% surface corrosion noted.

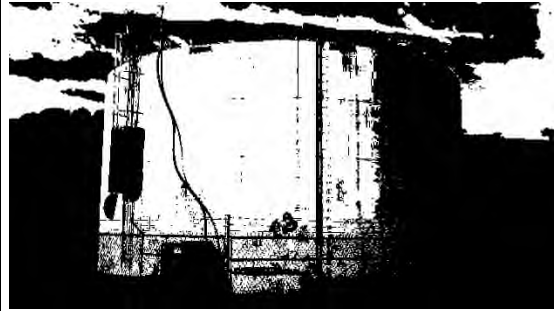
<b>Location:</b>	Exterior		
<b>Area:</b>	Shell		
<b>Adhesion:</b>	2A		
<b>Overall Condition:</b>	Poor		
<b>Dry Film Thickness:</b>	<b>Minimum</b>	<b>Maximum</b>	<b>Average</b>
	0.90	15.8	7.6

Condition	<i>Severe</i>	<i>Advanced</i>	<i>Moderate</i>	<i>Slight</i>	<i>None/NA</i>
<b>Rusting</b>			●		
<b>Blistering</b>					●
<b>Cracking</b>			●		
<b>Peeling</b>			●		
<b>Pitting</b>					●
<b>Chalking</b>	●				
<b>Delamination</b>			●		
<b>Comments:</b> Moderate rusting, cracking, peeling and delamination throughout, severe chalking throughout, various locations with observed damage from shotgun fire

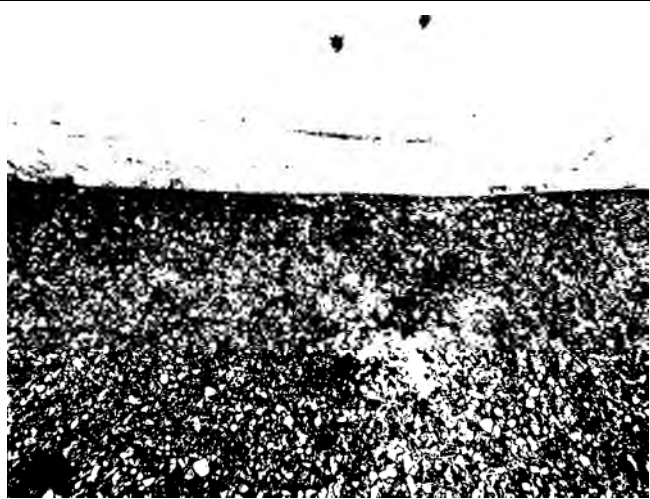
Summary: The base of the tank was found in good condition.

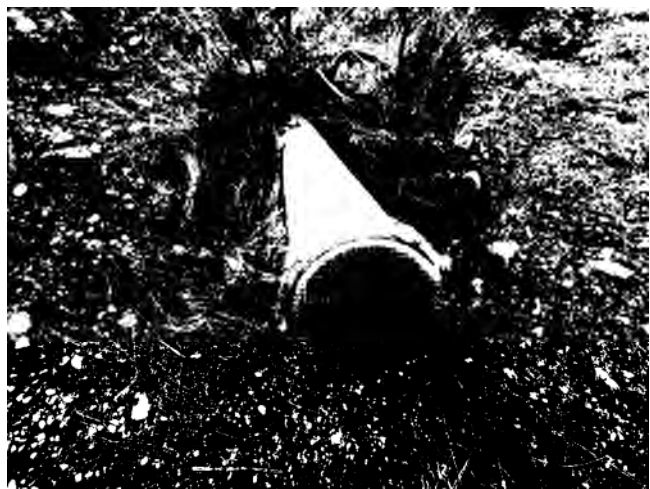
Summary: The overflow was found in good condition with minor de-lamination and sags & runs in the coating noted.

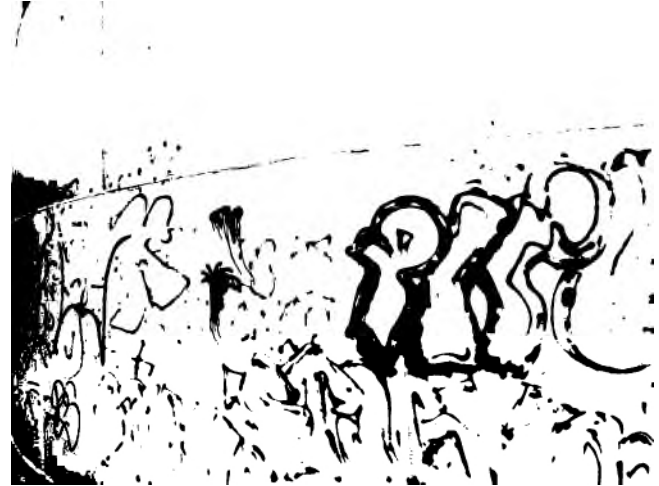
Graffiti

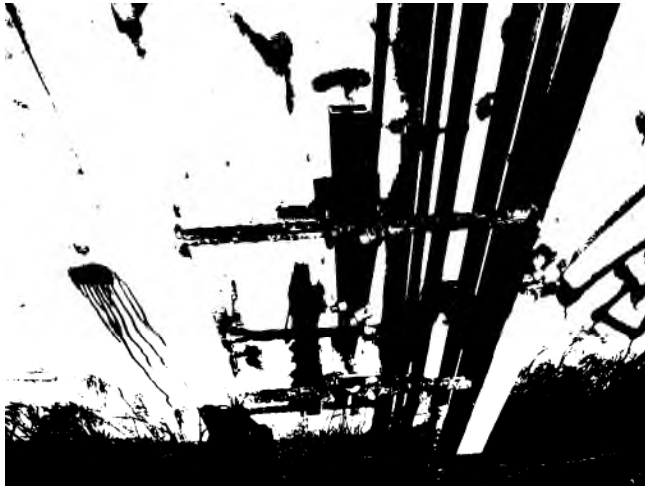
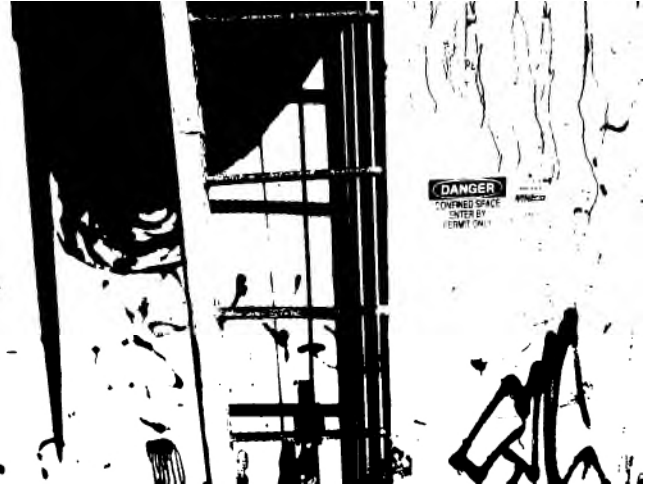
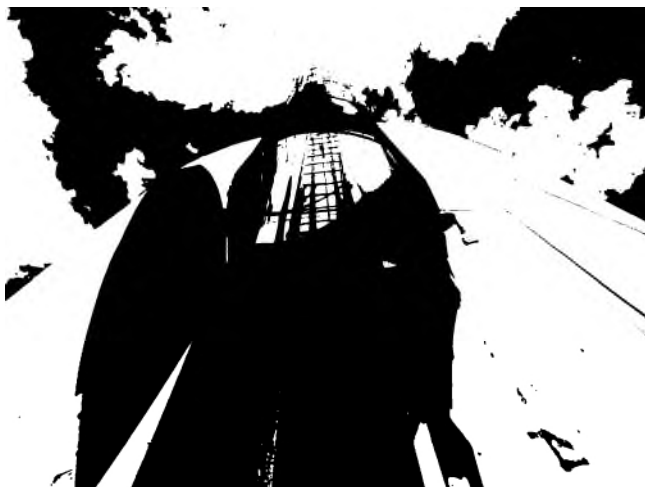
Safety cage

Summary: The ladder was found secure, OSHA approved and in good condition with minor de-lamination and 0.1% uniform surface corrosion noted.

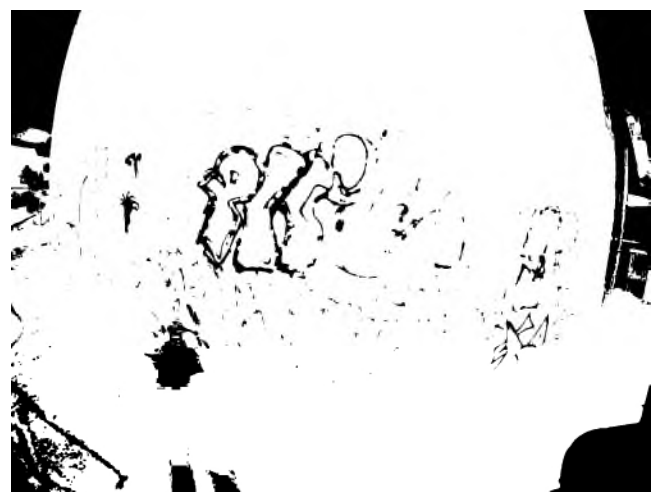
Summary: The wall was found in good condition with minor sags & runs in the coating, de-lamination, staining, graffiti and 5% uniform surface corrosion noted.

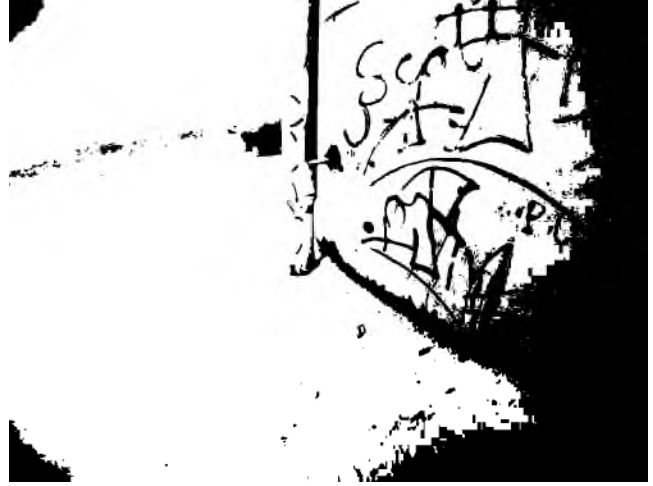
Summary: The overflow was found in good condition with minor de-lamination, staining and 3% uniform surface corrosion noted and is directly connected to the storm drain.

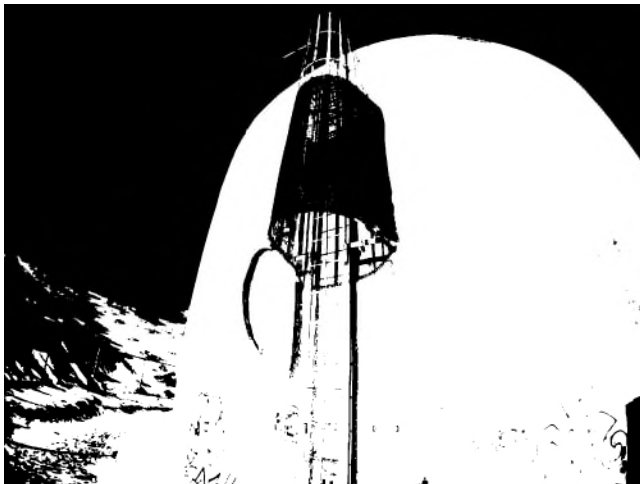
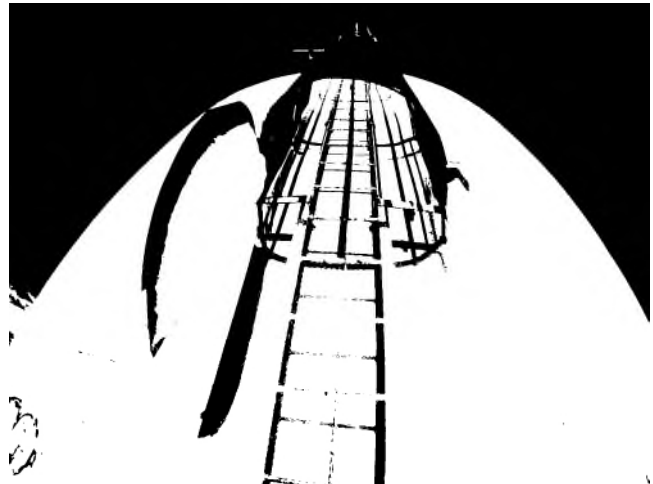
Summary: The ladder was found secure, OSHA approved and in good condition with minor staining, minor to moderate de-lamination and 3% uniform surface corrosion noted.

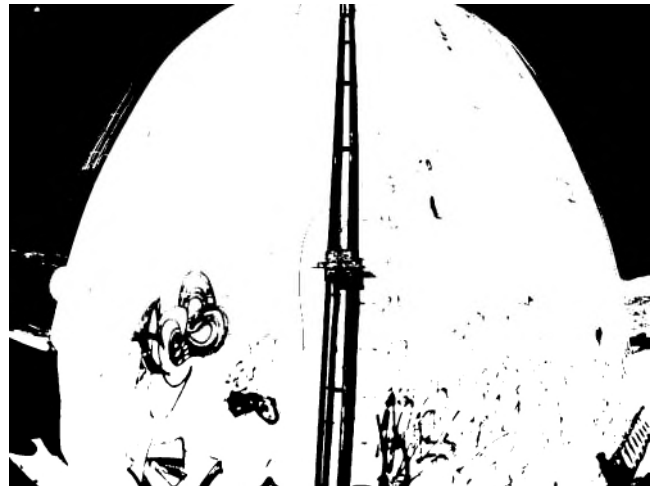
Summary: The water level indicator was found in good condition.

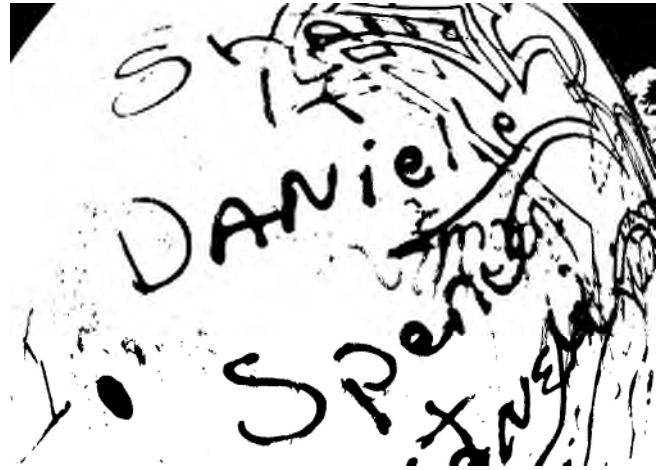
### Wall Panel Condition

Summary: The wall was found in good condition with minor sags & runs in the coating, chalking, de-lamination, blistering, 0.01% uniform surface corrosion and graffiti noted.

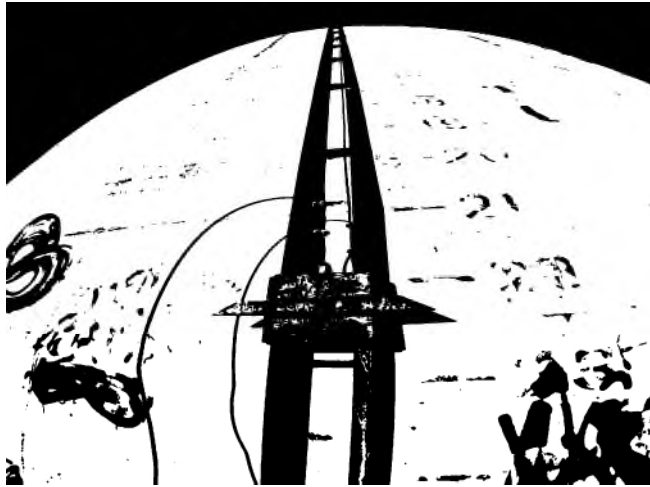
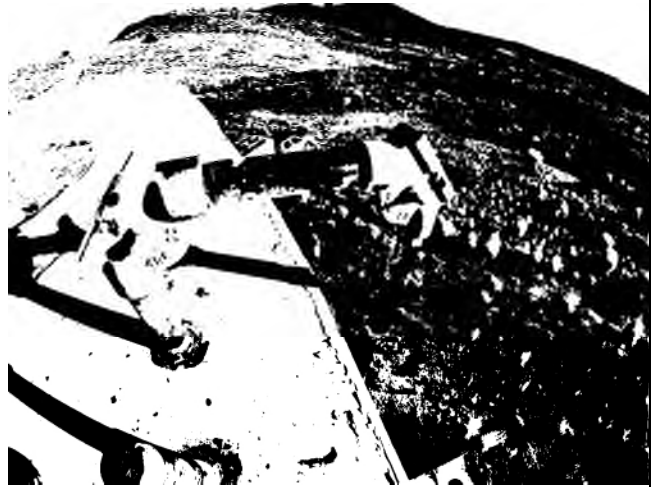
### Water Level Indicator Condition

Summary: The water level indicator was found in fair condition with 0.1% uniform surface corrosion noted.

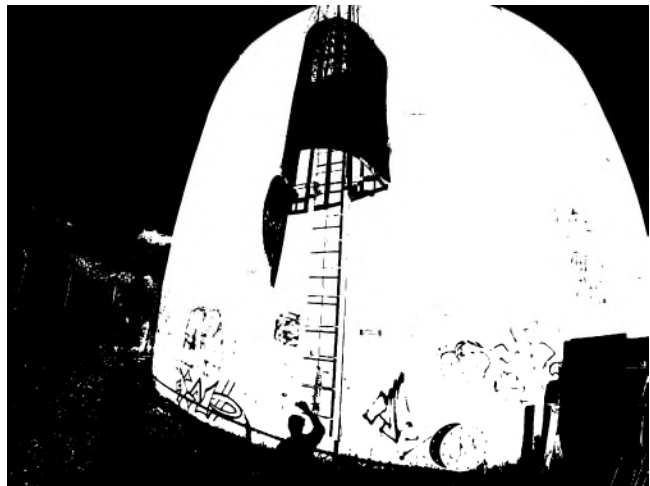
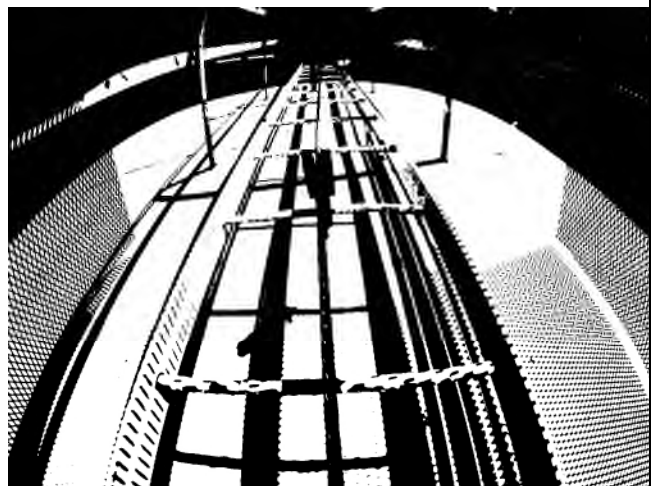
### Access Ladder Condition

Summary: The ladder was found secure, OSHA approved and in good condition with minor sags & runs in the coating, de-lamination and 0.1% uniform surface corrosion noted.

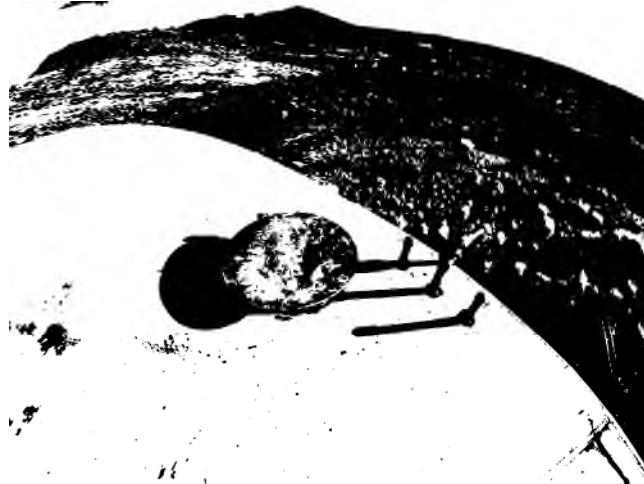
### Access Hatch Condition

Summary: The hatch was found locked with a gasket in place and in good to fair condition with greater than 50% uniform surface corrosion noted.

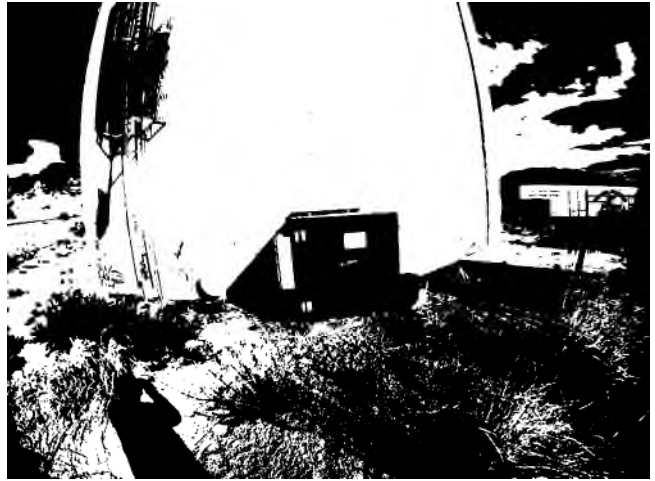
Summary: The water level indicator was found in good condition with 0.01% concentrated cell corrosion noted.

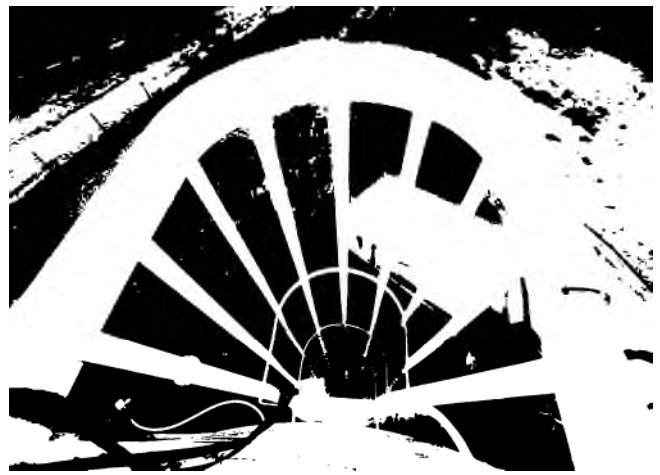
Summary: The ladder was found secure, OSHA approved and in good condition with 0.01% uniform surface corrosion noted.

Top of safety cage

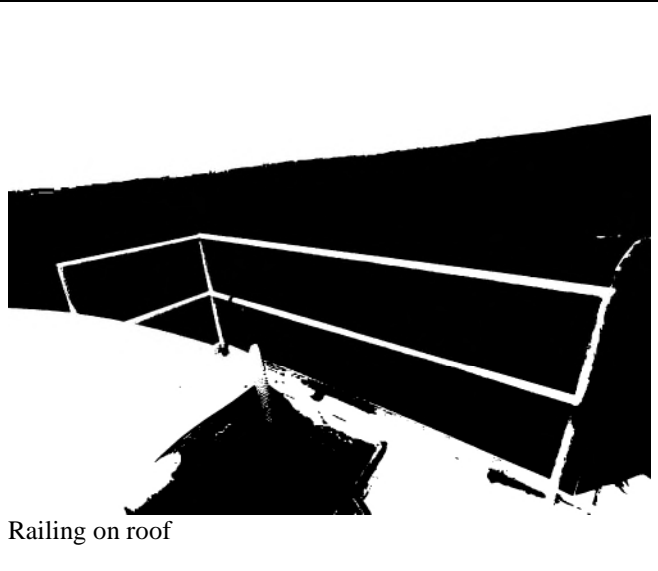
Railing on roof

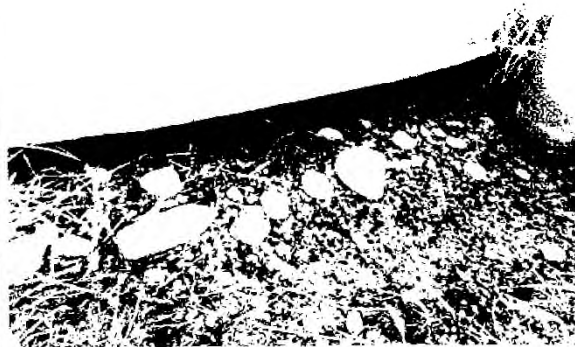
Summary: The base of the tank was found in fair to poor condition with what appears to be erosion beginning to occur.

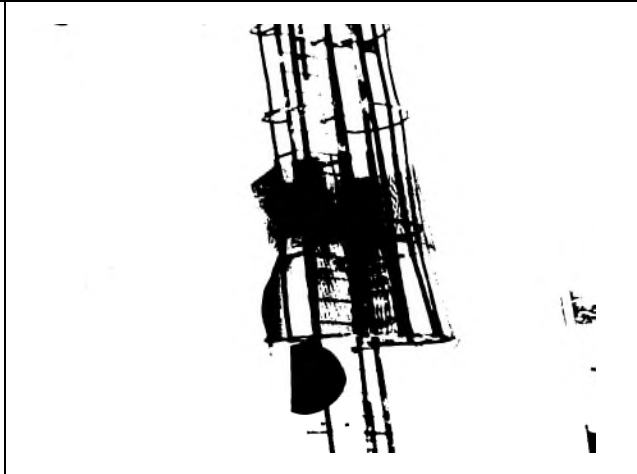
Summary: The ladder was found secure, OSHA approved and in good condition with oxidation and corrosion noted.

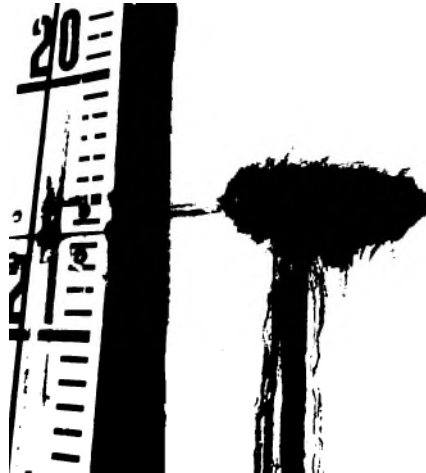
Summary: The wall was found in poor condition with sags & runs in the coating, chalking, dents, oxidation and 1% corrosion noted. There is also a leak over one of the manways.

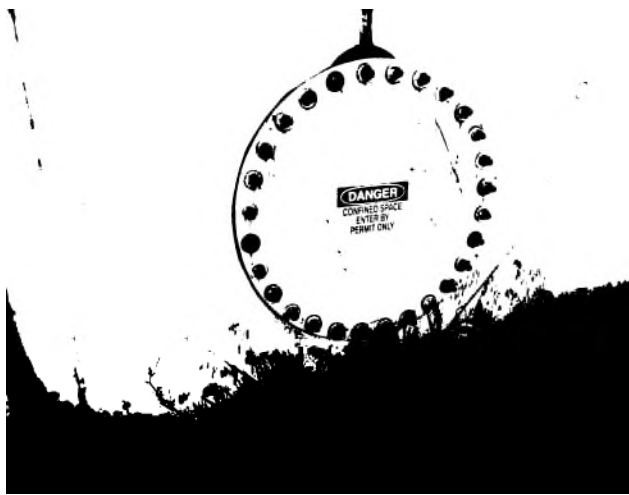
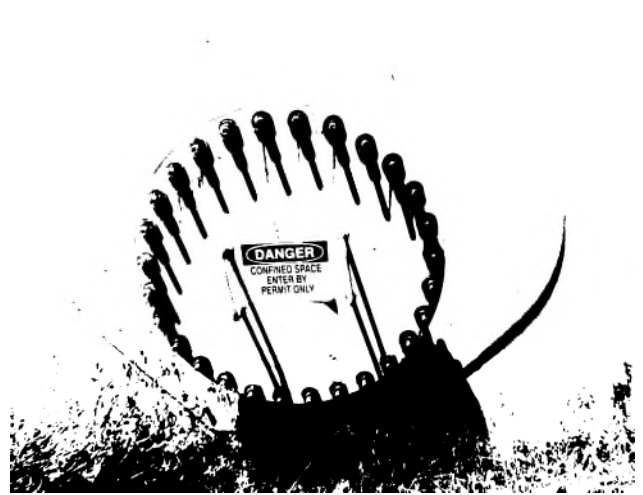
Summary: The manways were found secure and in good condition with 2% corrosion noted.
